The Use of ITS Technologies in Collision Response & Investigation

Presented By Raid Tirhi, Senior ITS Engineer

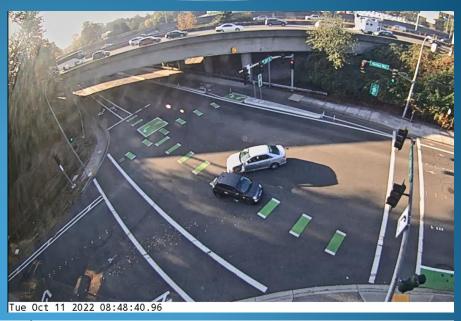
FYA- Collision Investigation

- Camera at subject intersection lost com
- Upstream camera barely shows the collision but no signal displays
- Collision happened at about 12:03:47pm.
- From the traffic signal history file, the collision happened during the westbound signal phase Stage "A" which includes a Flashing yellow Arrow (FYA).
- The time stamps of both systems are based on an atomic clock and are synched within a second.
- SB left vehicle did not yield on a FYA.

D1 stated that they were EB on Northup Way at the intersection of NE 24th Street. D1 stated that the sun was low in the sky making it difficult to see. D1 stated that he put his head out the window to check for WB traffic. D1 stated that he made a left turn on a flashing yellow light and collided with V2 in the intersection. D1 stated that he did not see V2 until after the collision. It should be noted on video I was able to zoom in on D2 and confirmed that he did look out the driver window attempting to clear the intersection prior to entering it.

I reviewed Bellevue Transportation camera footage from the intersection. The footage showed V1 in the left turn lane. D1 looked out their open window after stopping. V1 proceeded into the intersection and struck V2. V2 is observed swerving to avoid the collision but was unable too. A copy of the footage was booked into Quetel digital evidence.

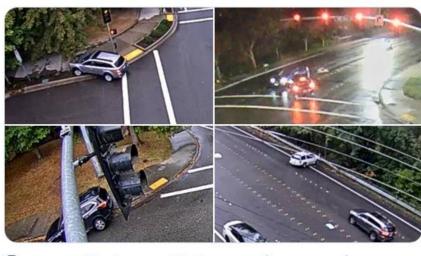
These images from our traffic cameras are examples of drivers losing control on Bellevue streets. Please slow down and be extra cautious!
